High human influence on beach response to tropical cyclones in small islands: Saint-Martin Island, Lesser Antilles

Virginie Duvat, Valentin Pillet, Natacha Volto, Yann Krien, Raphaël Cécé, et al.. High human influence on beach response to tropical cyclones in small islands: Saint-Martin Island, Lesser Antilles. *Geomorphology*, 2019, 325, pp.70-91. 10.1016/j.geomorph.2018.09.029 . hal-01924514

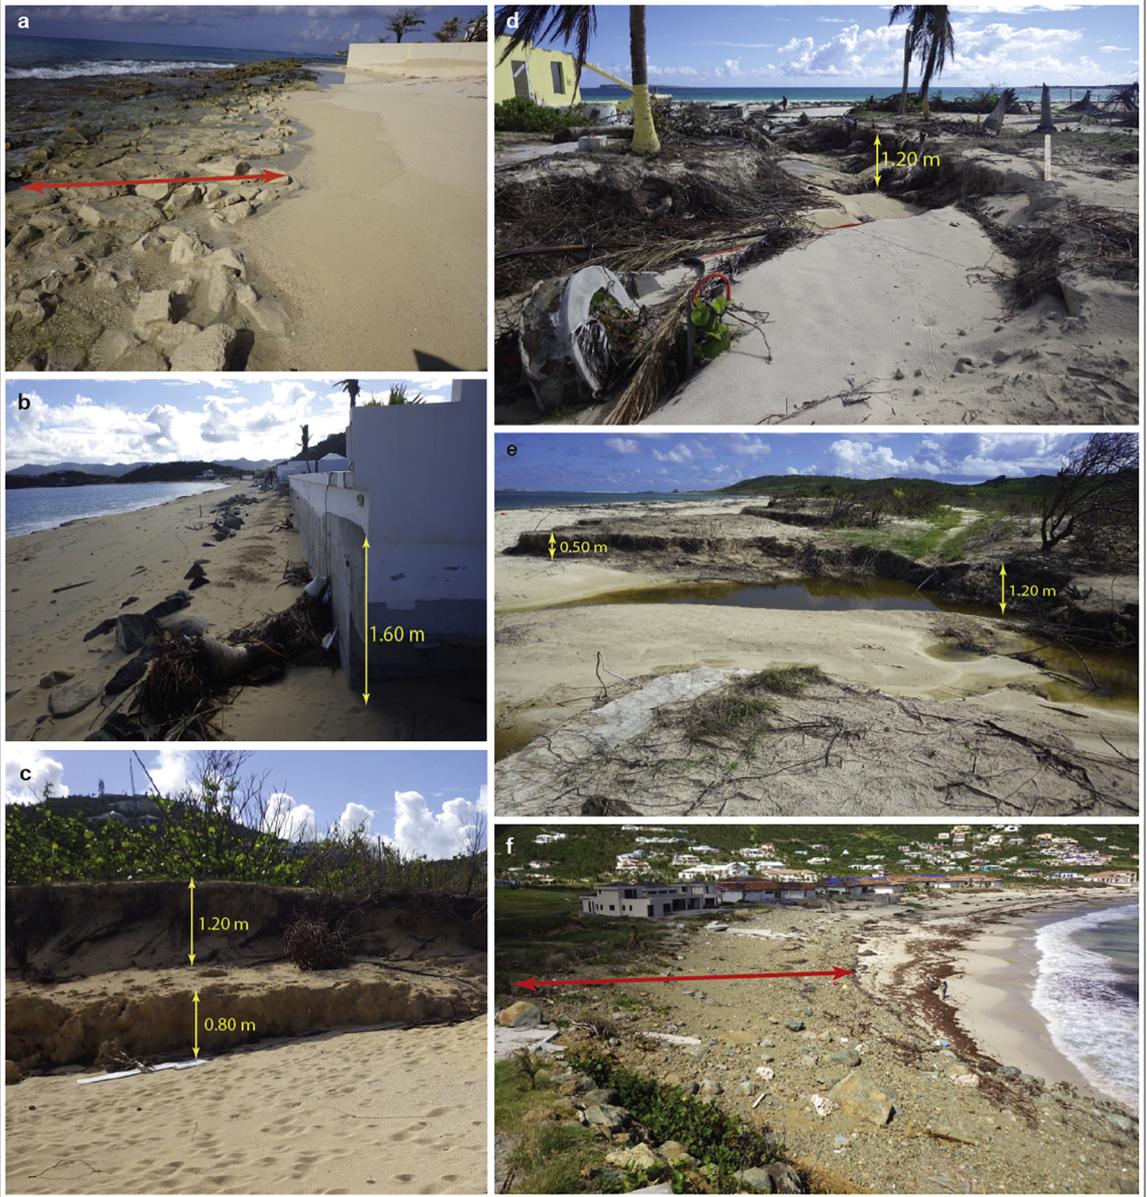
Figure 8

Generally, erosional features predominated in the beach, upper beach and sand dune edge areas (Fig. 8 and SM2). At most sites, beach lowering was revealed by the exhumation of buildings' foundations and of previously buried beachrock slabs (Fig. 8a). The highest values of beach lowering, reaching up to 2 m locally, were observed in front of buildings and seawalls protruding onto beaches (e.g. Red Bay, Fig. 8b). Although beach recovery had started at the time of our field visit, the erosional impacts of the cyclones were still clearly shown first, by the erosion scarps cut into the upper beach (generally 0.30 to 0.80 m high) and sand dunes where the latter occur (with scarps ranging from 1.50 to 4 m in height at Longue Bay and Red Bay; Fig. 8c), and second, by the exhumation of the root system of the destroyed vegetation over a 5 to 40 m-wide coastal strip (Figs. 8d, 8e). The height of erosion scarps was proportional to land elevation, thereby varying significantly between low-lying barrier beaches, where it ranged from 0.30 to 0.60 m, and beach-dune systems, where it reached up to 4 m. In places, scour holes and soil scouring were also noted (e.g. at Petites Cayes Bay, Orient Bay, Embouchure Bay and Guana Bay; Figs. 8e, 8f), which extended from the upper beach to inner land areas over distances ranging from a few metres to around twenty metres. On the most affected eastern site, namely Orient Bay, wave attack even led to the formation of a 1.20 m-deep and 15 m-long trough, extending transversally to the shoreline from the upper beach to inner land areas (Fig. 8d).

Shoreline hardening also had impacts on erosional and accretional cyclone-driven processes. Beach lowering was greater in front of seaside property walls and seawalls, where it reached up to -2 m (Figs. 8b, 10c, 10d), compared to non-built shoreline sections where values <0.80 m were observed. In addition, where sediment transport pathways were obstructed by human constructions, sand accumulation only occurred in devastated buildings and swimming pools (Figs. 10f-g), and in gaps between buildings (Fig. 9b). Where human constructions were continuous along the shoreline, sediment deposition on upper beaches and over inland areas was either absent or very limited (Fig. 10a). At the time of the field visit, in settled residential areas, invading sand deposits had been cleaned and raked-up into piles by residents (Fig. 10g). Longitudinal constructions therefore exacerbated the erosional impacts of the cyclonic waves on beaches, while limiting sediment deposition on upper beaches and over inland areas.

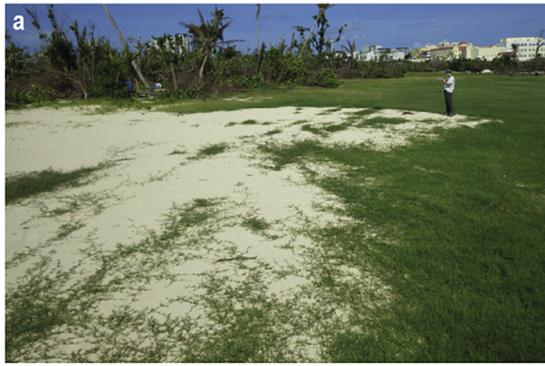
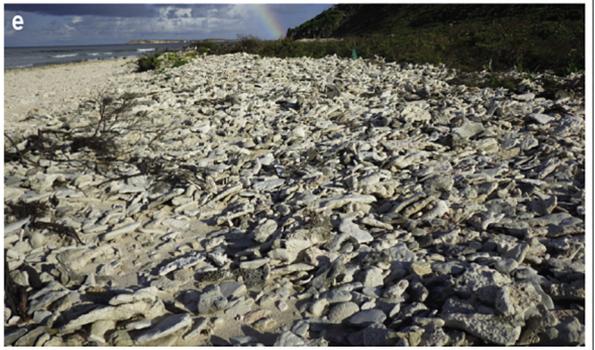
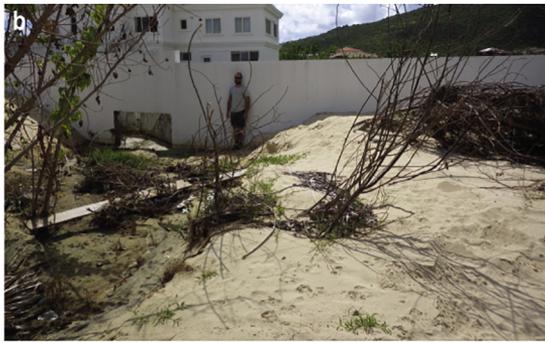
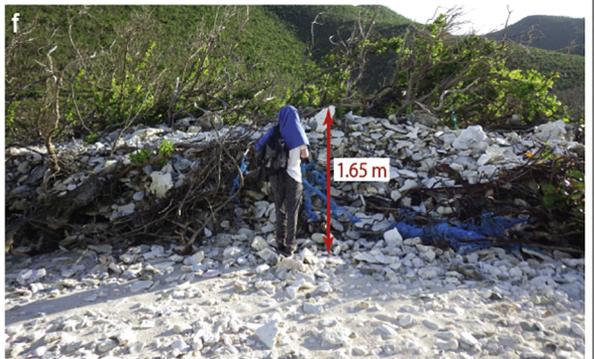
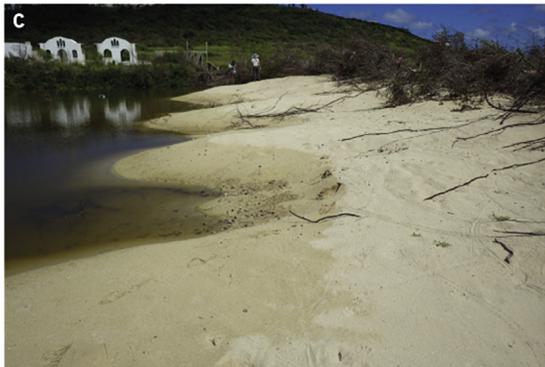
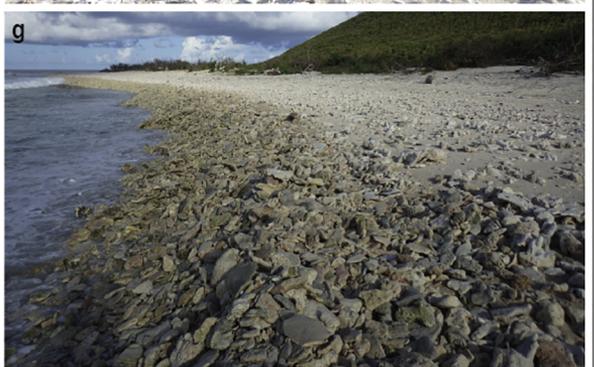
Figure 9

a Cyclone-generated 2 to 8 cm-thick sand sheets extending over a maximum distance of 75 m from the pre-cyclone vegetation line, central part of Mullet Bay. b 0.80 m-thick sand deposits recorded in open areas between buildings at Guana Bay. c and d Gibb's Bay. c Sediment deposition resulting from wave overwashing of the 40-50 m-wide barrier beach. Sand lobes formed along the entire lagoon-side shoreline. d Sand deposition against the natural vegetation in the inner part of the barrier beach. e, f and g show accretional features observed on Petites Cayes Beach. e The beach ridge that formed at the top of the shrubby vegetation, as a result of the transfer of coral debris and blocks from the fringing reef to the beach. f Major role of the dense coastal vegetation in trapping coral debris and blocks. g Crescent-shaped shingle deposit structure that formed at the base of the beach. h Beachrock fragments' accumulation against cyclone-generated erosion scarps cut in Longue Bay sand dunes. These deposits result from the dismantling of exhumed beachrock slabs that can be seen in the wave breaking zone on the same photograph.

While erosion predominated on beaches and upper beaches, sand accumulation prevailed in inner land areas as a result of overwash where no obstacle, neither natural (i.e. dense vegetation) nor human-built (i.e. buildings and engineered structures), obstructed sediment transport pathways. Extensive sand sheets indicating massive sediment transfer from beaches to

inner land areas were the most common feature observed (Fig. 9, SM3). In open areas, sand deposits penetrated inland over great distances, i.e. 135 m, 105 m and 75 m from the pre-cyclone vegetation line at Simpson Bay, Nettle Bay (west) and Mullet Bay, respectively (Fig. 9a). At most sites, the maximum thickness of these sand sheets ranged from 0.10 to 0.80 m (Fig. 9b). It reached the maximum value of 2 m on the highly-exposed eastern coast at Gibb's Bay (Fig. 9d). Moreover, at two sites (i.e. Red Bay and Gibb's Bay), barrier beach overwashing by the cyclonic waves caused sediment deposition in the inner lagoon, where sand lobes formed (Fig. 9c). In addition, at one site (i.e. Embouchure Bay), a new channel (maximum dimensions of 15 m x 75 m) formed across the barrier beach. Of note, on the north-eastern back-reef beaches (namely Petites Cayes Bay and Petites Cayes Beach), the substantial transfer to the coast of coral debris (primarily shingle and rubble, and secondarily blocks) led to the formation of crescent-shaped deposits at the base of the beach (Fig. 9g) and of a 0.80 m-high, 20 m-wide and 60 m-long beach ridge on the upper beach (Fig. 9e). Additionally, on highly eroded beaches bordered with beachrock slabs, the dismantling and landward transfer of fragments of the latter caused block accumulation at the beach surface and along the erosion scarps cut by cyclonic waves in upper beaches and sand dunes (Fig. 9h).

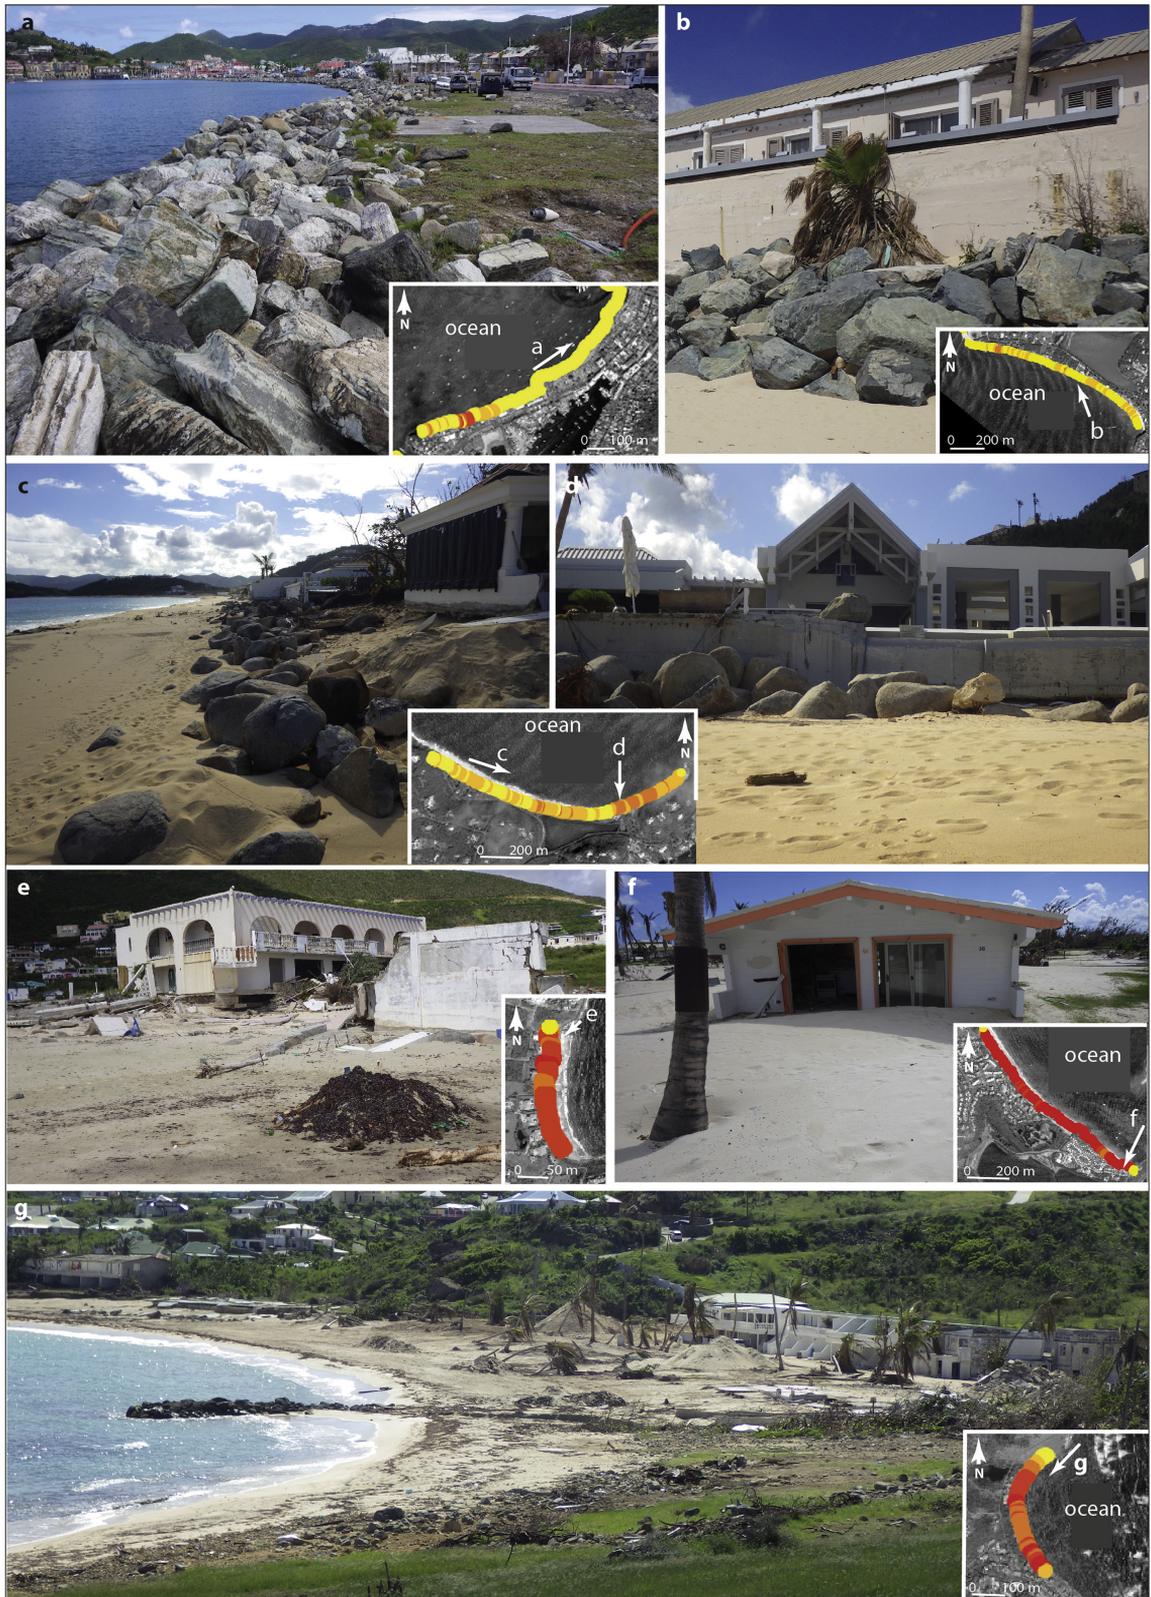
Figure 10

a to d Impacts of longitudinal constructions on shoreline response and on cyclone-driven erosional and accretional processes. On a (Marigot Bay) and b (Longue Bay), as a result of the construction of massive engineered structures (here, rip-raps), the stability line exhibited positional stability. On c and d (Red Bay) rip-raps, which were constructed by seaside residents, were partially dismantled by the cyclonic waves. As a result, wave reflection on the frontage of houses caused marked beach lowering (-0.80 to -1.60 m on c, and -1.50 to -2 m on d), exhuming buildings foundations. On e (Guana Bay) seaside houses were either wiped out by the cyclonic waves (on the foreground), or severely damaged (on the background). Here too, wave reflection caused marked beach lowering (up to -2 m in front of buildings). f (southern end of Orient Bay) illustrates widespread sand deposition in cleared areas. Here, at a distance of 60 m from the pre-cyclone stability line, sand deposits reached 0.80 m in thickness. g Piles of sand resulting from the removal of cyclonic deposits (around 300 m^3) both inside and in front of seaside properties along the 100 m-long urbanized shoreline section of Lucas Bay.

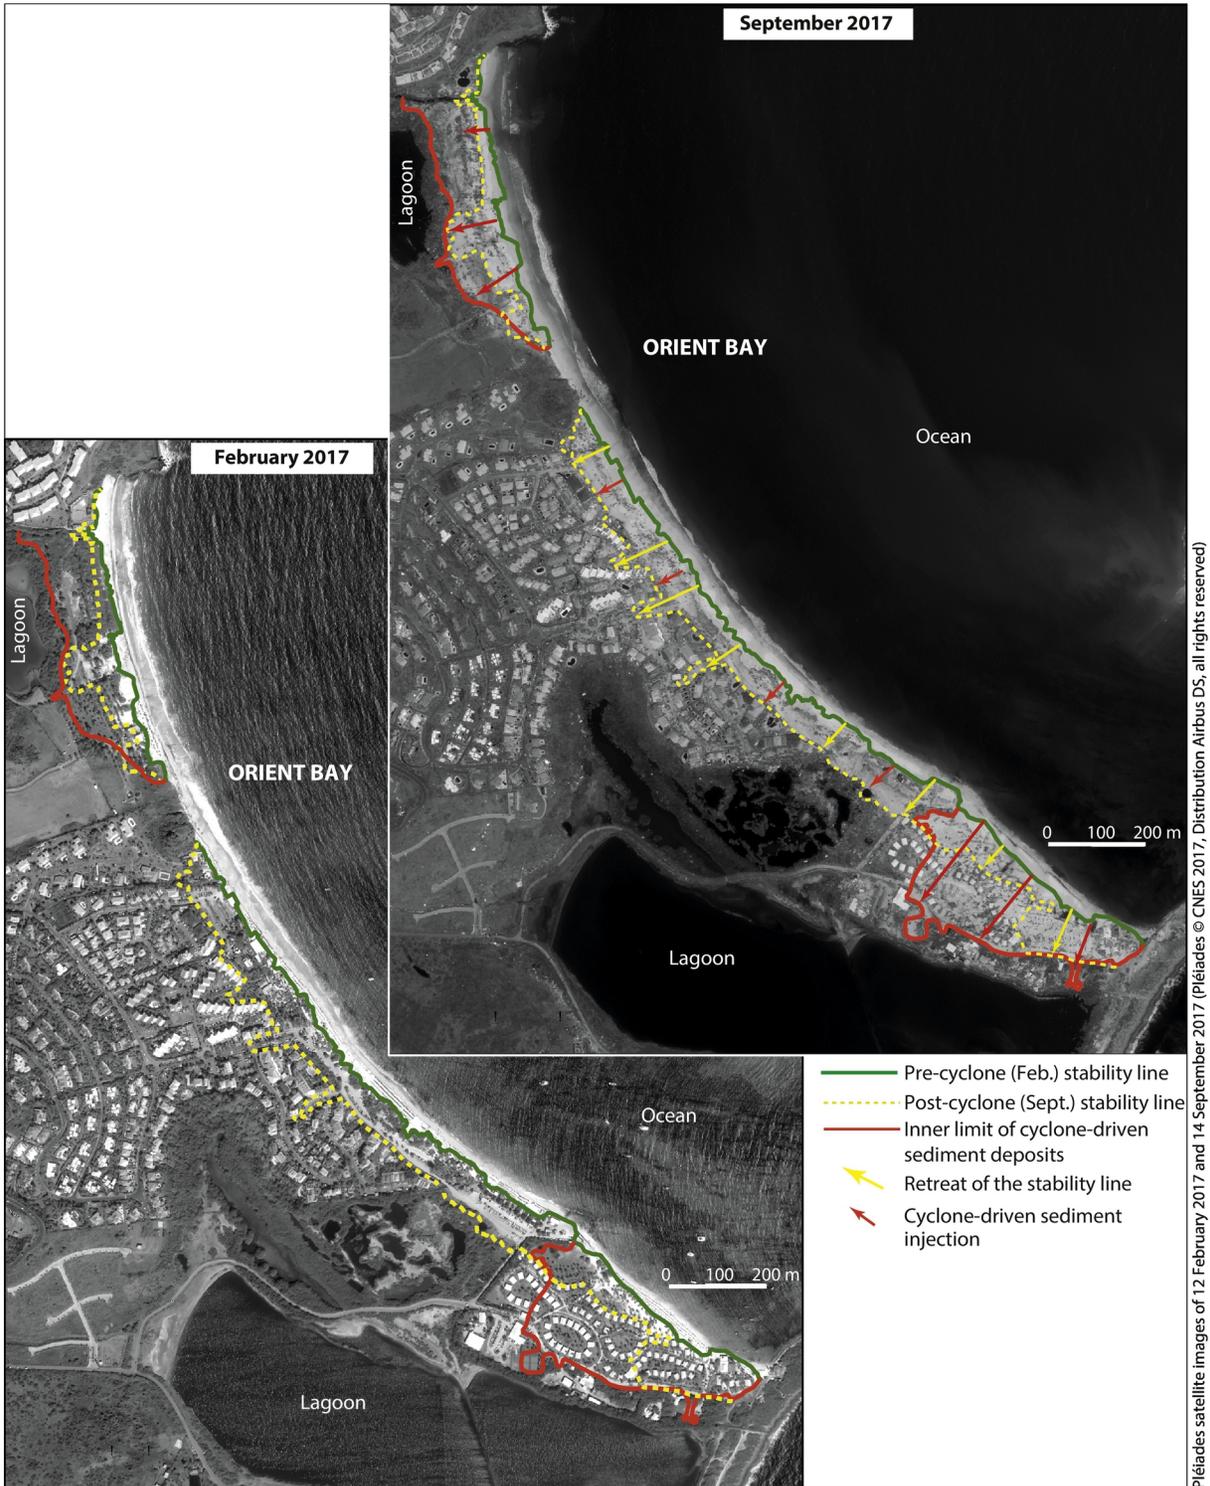
Figure 13

As a result of population growth and tourist development, this beach type prevails. Barrier beaches and beaches exhibiting vegetation modification, including change from indigenous to introduced species and vegetation clearing (e.g. northern part of Embouchure Bay, Orient Bay), underwent marked shoreline retreat and sand loss (indicated by 0.30 to 1.50 m-high erosion scarps), to which vegetation modification contributed. Generally, the indigenous vegetation was either partly or entirely removed for development purposes, and replaced by an urbanized seafront providing diverse amenities (parking areas, shops, etc.). As a result, highly-exposed buildings protruding onto the beach had to be protected from wave attack by engineered structures. In such a configuration, both the amplification of cyclone-induced beach erosion and soil scouring, and of marine inundation by vegetation removal, and the suppression of cyclones' constructional impacts by the removal of sediment deposits, led to an increase in the vulnerability of the beach system and in the exposure of the human assets established in the coastal plain.
